Manhole Inspection Summary

Manhole # S29KK_047MH

Insp Date: **4/12/07 9:52 AM**

Location Address: **1737 PARK AVE**

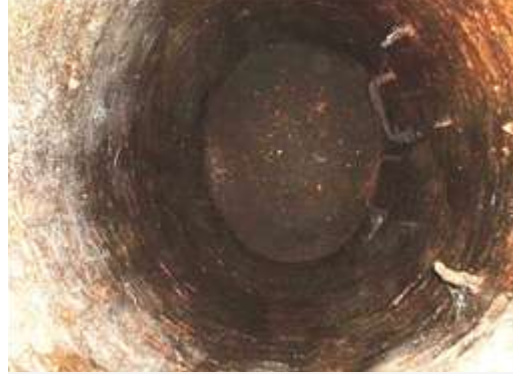
Top View

☒ **Debris** (not Condition related)

Count: **5** Missing: **3** ☒ **Corroded**

Corroded and mssing steps. Channel debris.

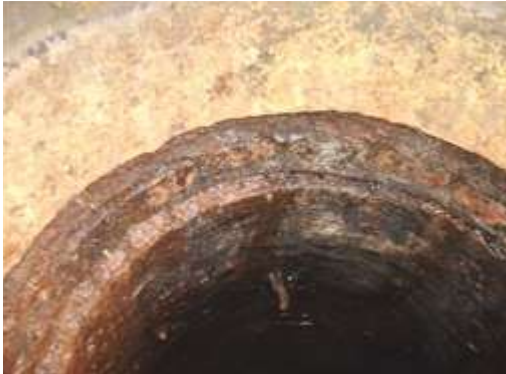
Defect

☒ **Leaks**

Infiltration: ☐ None ☒ **Joint** ☐ Cracks ☐ Mortar ☐ Roots ☒ **Wall**

Frame leaks. Adjustment infiltration - other side.

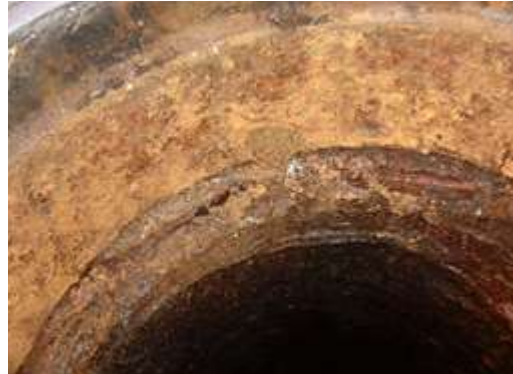
Defect

Frame leaks. Adjustment infiltration.

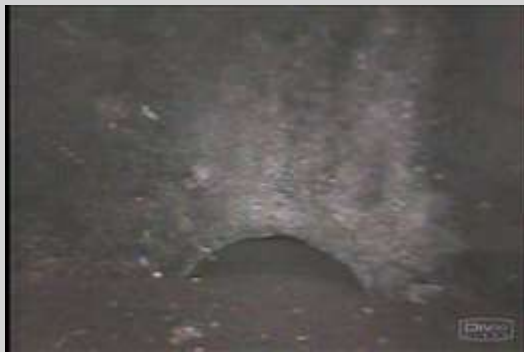
8 in. Circular Gravity Sewer
Pipe Out @ 12 O'Clock

Deposits: ☐ None ☒ **Mud** ☐ Sludge ☒ **Debris** ☐ Grease

Silt Depth: **6** (in.) Deposits Extent: **Heavy**
